# Dentistry Clinical

## Engineering the solution

Harry Shiers presents a case report on the restoration of a unilateral posterior maxilla with an implant-retained bridge

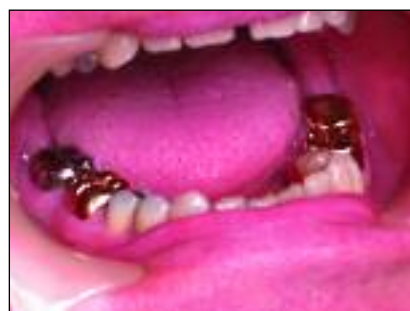
Figure 1: The patient demonstrated fairly heavily restored dentition

On examination, the patient demonstrated a fairly heavily restored dentition with one metal ceramic crown and five amalgam restorations in the maxilla and four gold crowns, (two of these teeth root treated) and three further restorations in the mandible (Figure 1). The most extensive restorative work was in the posterior segments and there was evidence on the teeth of a bruxing habit.

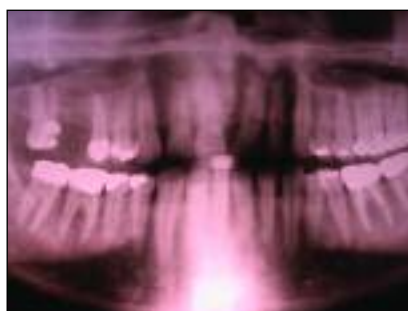
Figure 2: The DPT of the patient at presentation. The periapical radiolucency associated with the mesio-buccal and palatal roots may be seen

Figure 2 shows the DPT of the patient at presentation. The periapical radiolucency associated with the mesio-buccal and palatal roots may be seen. Figure 3 shows a digital periapical image of the upper

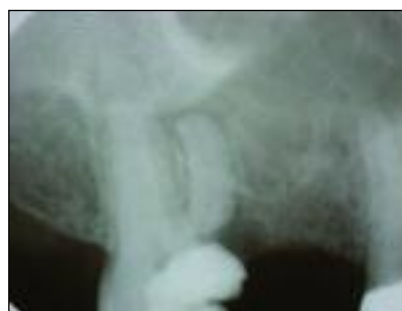
Figure 3: A digital periapical image of the upper right second molar and upper right second pre-molar, where the extent of the decay in the maxillary second molar is seen more clearly

right second molar and upper right second pre-molar, where the extent of the decay in the maxillary second molar is seen more clearly.

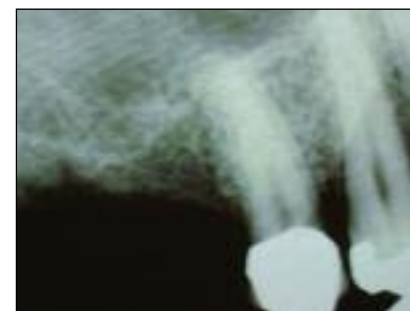
Figure 4: Two further periapical radiographs were taken prior to the selection of the implants

and luxators. The patient was reviewed one week later and healing had been uneventful. A pre-operative appointment was made for the end of March when two further periapical radiographs were taken prior to the selection of the implants (Figure 4).

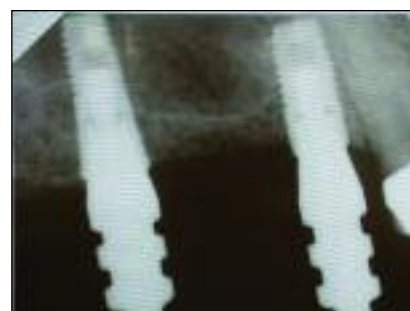
Figure 5: The impression copings in

The second stage surgery was performed two and a half months after implant placement. Head-of-implant impressions followed this three weeks later. Figure 5 shows the impression copings in situ. Once the model had been cast with the appropriate replicas, two 20-degree taper uni-abutments were selected for construction of a screw-retained bridge (Figure 6). Figure 7 demonstrates the implant-retained bridge on the model.

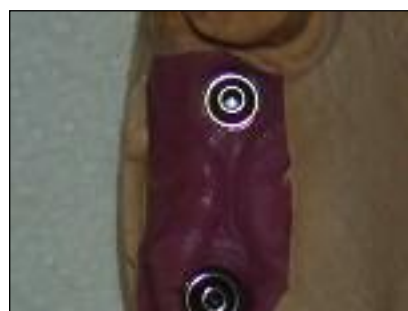
Figure 6: Uni-abutments were selected for construction of a screw-retained bridge

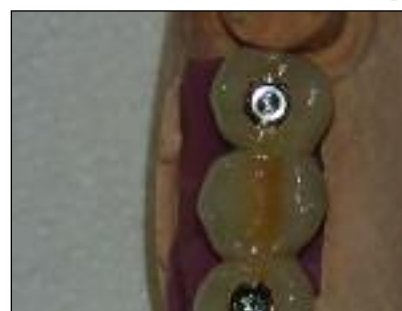
Figure 7: The implant-retained bridge

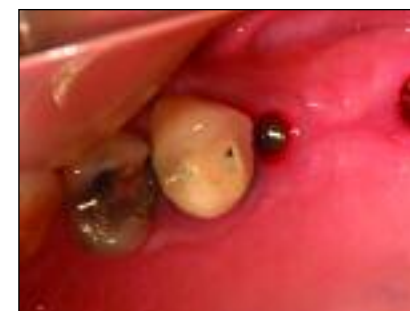
Figure 8: Two new uni-abutments were fitted

The next appointment was the fit stage, where two new uni-abutments were fitted (Figure 8) and the bridge attached with two bridge screws, the screw heads covered with cotton wool and the screw hole filled with

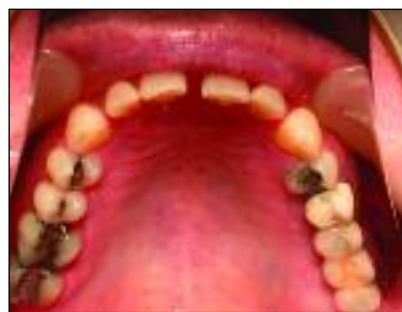
Figure 11: The temporary restorative material was replaced with composite. Figure 12: The bridge in centric relation from the buccal aspect.

The patient was reviewed at two weeks and three months, at the latter appointment the cotton wool and temporary restorative were changed and the temporary restorative replaced with composite (Figure 11). Figure 12 shows the bridge in centric relation from the buccal aspect. Figures 13 to 16 show radiographs at intervals up to March 2009.

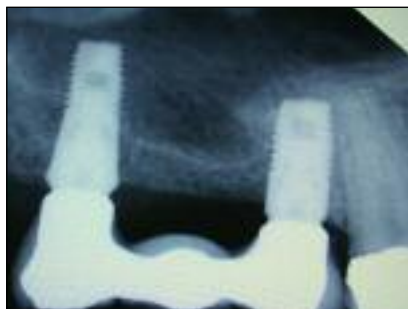
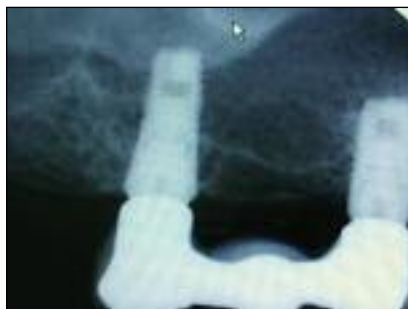
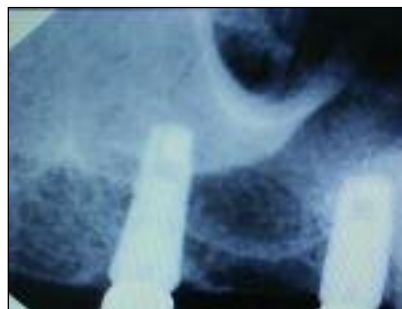
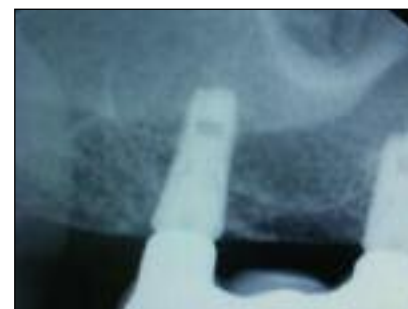
Figures 13-16: Radiographs at intervals up to March 2009.
