Implant and restorative case study

Harry Shiers illustrates the restoration of a right side posterior maxilla from a failing one-piece three-unit bridge supported by three root-treated post and core restored teeth

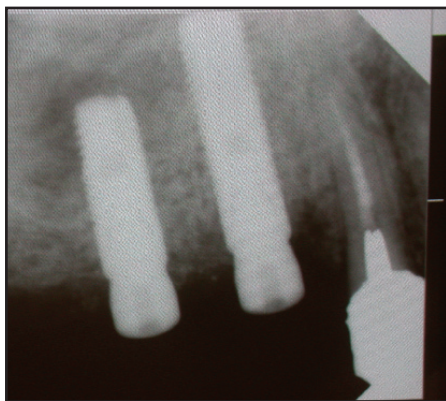
Figure 4: a radiograph taken at this visit (four-month second surgical stage)

After four months a second stage surgical was performed and 3.0mm Zebra healing abutments fitted into both implants two Vicryl sutures were placed. The patient returned for suture removal one week later. (Figure 4) demonstrates a radiograph taken at this visit (Figure 5) shows the zebra healing abutments.

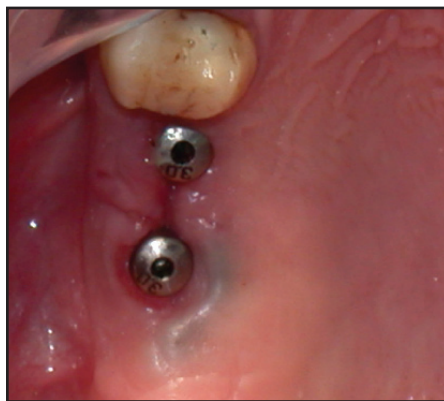
Figure 5: Zebra healing abutments at the four-month second surgical stage

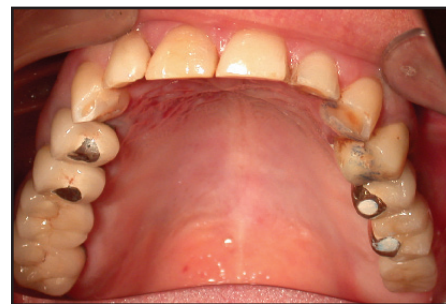
Figure 6: An occlusal view - mirrored

were replaced with two Astra 20 degree taper uni-abutments and a screw-retained bridge was fitted.

The occlusion was checked initially with 20-micron articulating paper and then with Schimstock. The screw holes were filled with Cavit after protecting the screw heads with cotton wool. (Figure 6) shows an occlusal view and (Figure 7) shows a buccal view. A PA radiograph was taken using a guiding device (Figure 8) to act as a baseline radiograph and the patient was asked to return for review in two weeks.

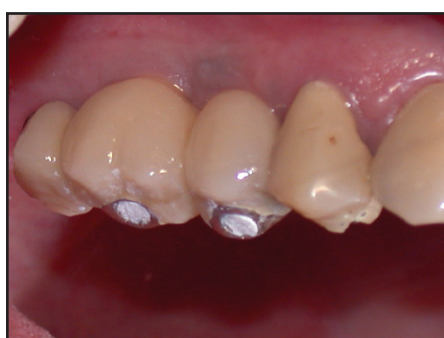
Figure 7: A buccal view

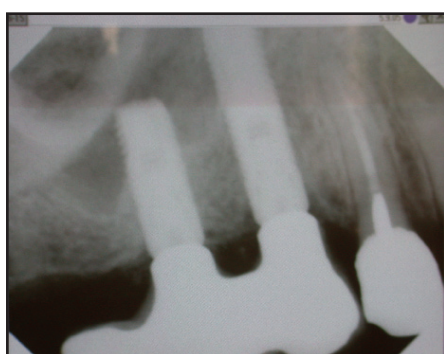
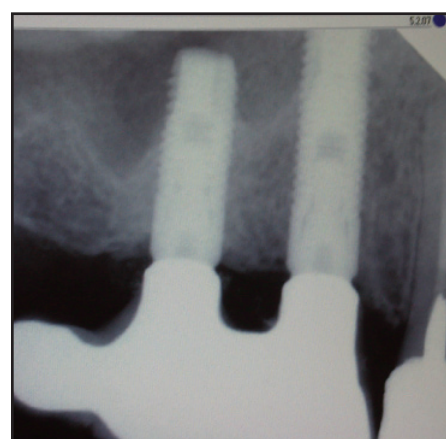
Figure 9 & 10: PA radiographs taken at nine months and 22 months post-operatively

(Figures 9 and 10) demonstrate PA radiographs taken at nine months and 22 months post-operatively. The treatment for further restorative work in other quadrants of the mouth is still ongoing, however the travel schedule of the patient has not permitted all the required work to be finished.
